SHEPHERD
HOME REPORT

4 ALBERT STREET
FRASERBURGH
AB43 9JL

Single Survey

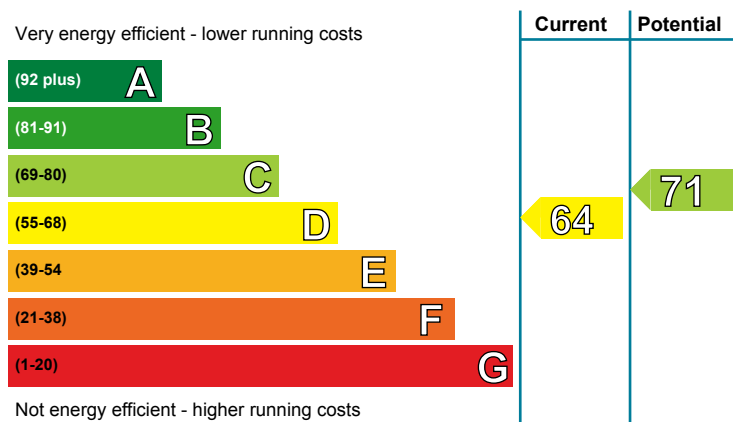
Energy Efficiency Rating

Your current rating is **band D (64)**. The average rating for a home in Scotland is **band D (61)**.

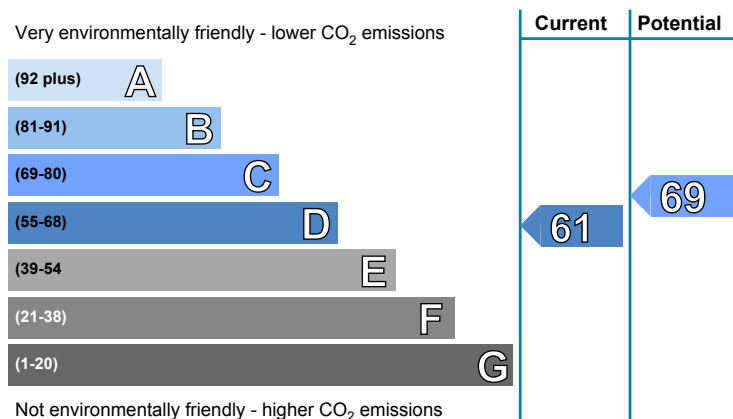
Environmental Impact (CO₂) Rating

Your current rating is **band D (61)**. The average rating for a home in Scotland is **band D (59)**.
