# HOME REPORT

36B MID STREET  
FRASERBURGH  
AB43 9AJ

36B MID STREET, FRASERBURGH, AB43 9AJ

**Dwelling type:** Top-floor flat  
**Date of assessment:** 17 April 2023  
**Date of certificate:** 28 April 2023  
**Total floor area:** 40 m<sup>2</sup>  
**Primary Energy Indicator:** 441 kWh/m<sup>2</sup>/year

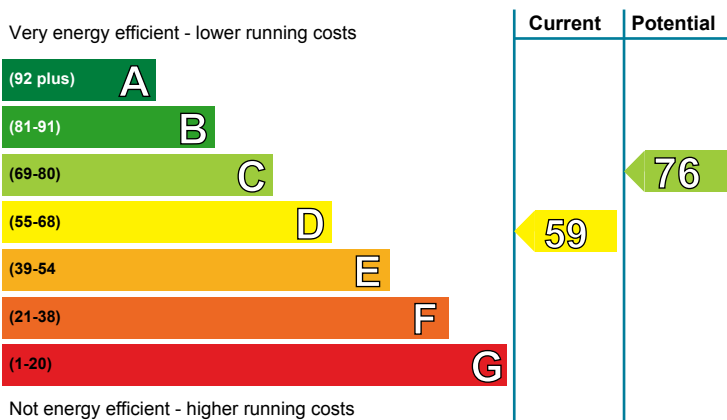
## Energy Efficiency Rating

This graph shows the current efficiency of your home, taking into account both energy efficiency and fuel costs. The higher this rating, the lower your fuel bills are likely to be.

Your current rating is **band D (59)**. The average rating for EPCs in Scotland is **band D (61)**.

The potential rating shows the effect of undertaking all of the improvement measures listed within your recommendations report.
