HOME REPORT

38A MID STREET
FRASERBURGH
AB43 9AJ

Energy Performance Certificate (EPC)

38A MID STREET, FRASERBURGH, AB43 9AJ

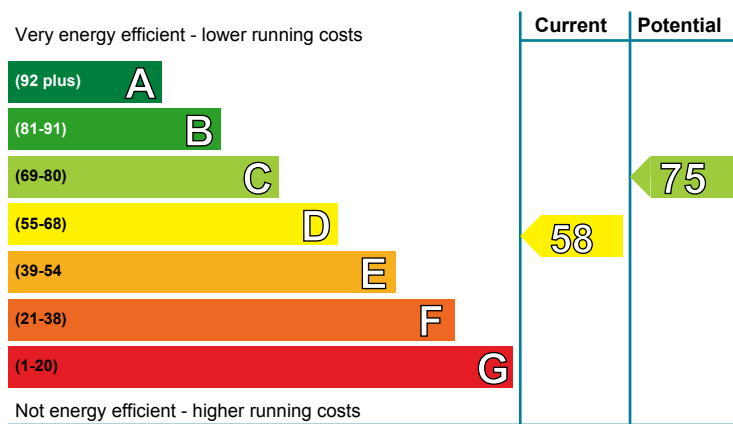
Energy Efficiency Rating

This graph shows the current efficiency of your home, taking into account both energy efficiency and fuel costs. The higher this rating, the lower your fuel bills are likely to be.

Your current rating is **band D (58)**. The average rating for EPCs in Scotland is **band D (61)**.

The potential rating shows the effect of undertaking all of the improvement measures listed within your recommendations report.

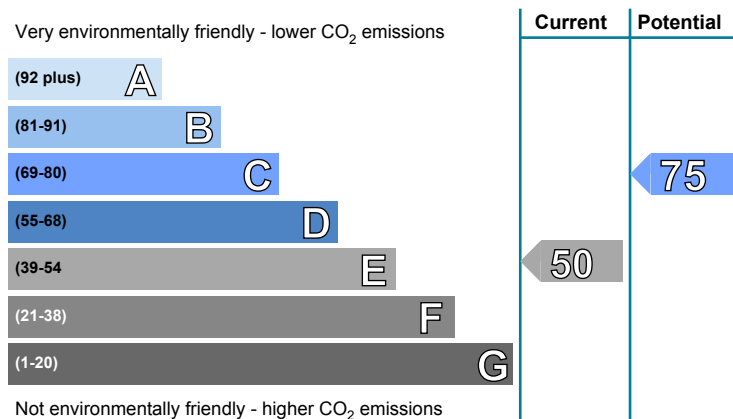
Environmental Impact (CO₂) Rating

This graph shows the effect of your home on the environment in terms of carbon dioxide (CO₂) emissions. The higher the rating, the less impact it has on the environment.

Your current rating is **band E (50)**. The average rating for EPCs in Scotland is **band D (59)**.

The potential rating shows the effect of undertaking all of the improvement measures listed within your recommendations report.
