# Home Report

# Single Survey

<b>Property address</b>	10 Mid Street Inverallochy Fraserburgh AB43 8YA
<b>Customer</b>	Roger Butler
<b>Customer address</b>	10 Mid Street Inverallochy Fraserburgh AB43 8YA
<b>Prepared by</b>	Shepherd Chartered Surveyors
<b>Date of inspection</b>	05/03/2024

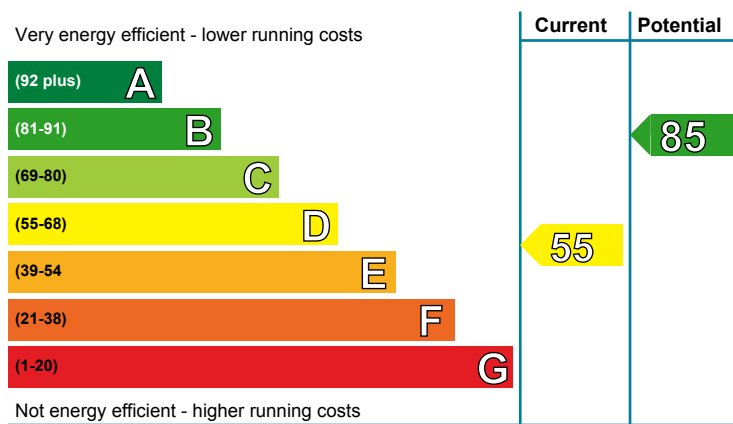
## Energy Efficiency Rating

This graph shows the current efficiency of your home, taking into account both energy efficiency and fuel costs. The higher this rating, the lower your fuel bills are likely to be.

Your current rating is **band D (55)**. The average rating for EPCs in Scotland is **band D (61)**.

The potential rating shows the effect of undertaking all of the improvement measures listed within your recommendations report.

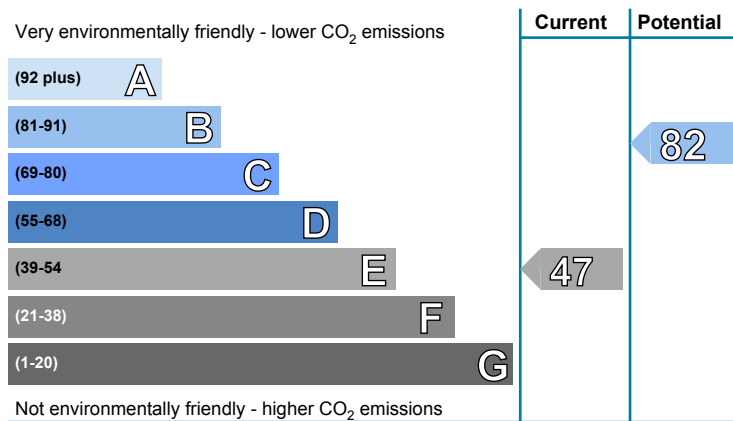
## Environmental Impact (CO<sub>2</sub>) Rating

This graph shows the effect of your home on the environment in terms of carbon dioxide (CO<sub>2</sub>) emissions. The higher the rating, the less impact it has on the environment.
