Home Report

Scottish Single Survey

Property address	19 Dingwall Street Rosehearty Fraserburgh AB43 7NR
Customer	James Watt
Customer address	Oceanview Peathill Rosehearty Fraserburgh AB43 7HD
Prepared by	Shepherd Chartered Surveyors
Date of inspection	10/07/2023

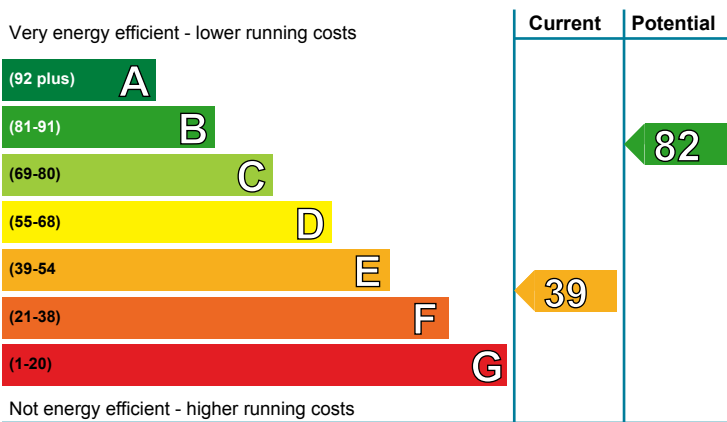
Energy Efficiency Rating

This graph shows the current efficiency of your home, taking into account both energy efficiency and fuel costs. The higher this rating, the lower your fuel bills are likely to be.

Your current rating is **band E (39)**. The average rating for EPCs in Scotland is **band D (61)**.

The potential rating shows the effect of undertaking all of the improvement measures listed within your recommendations report.

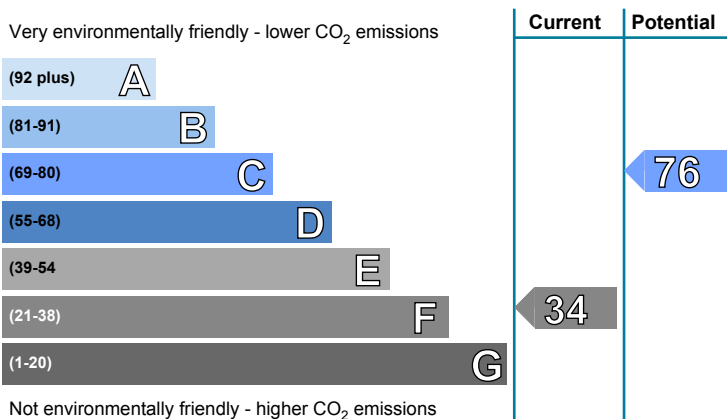
Environmental Impact (CO₂) Rating

This graph shows the effect of your home on the environment in terms of carbon dioxide (CO₂) emissions. The higher the rating, the less impact it has on the environment.
