HOME
report

SINGLE SURVEY
ENERGY REPORT
PROPERTY QUESTIONNAIRE
VALUATION REPORT

Single Survey

Property address	3 Clinton Drive, Sandhaven, Fraserburgh, AB43 7ES
-------------------------	--

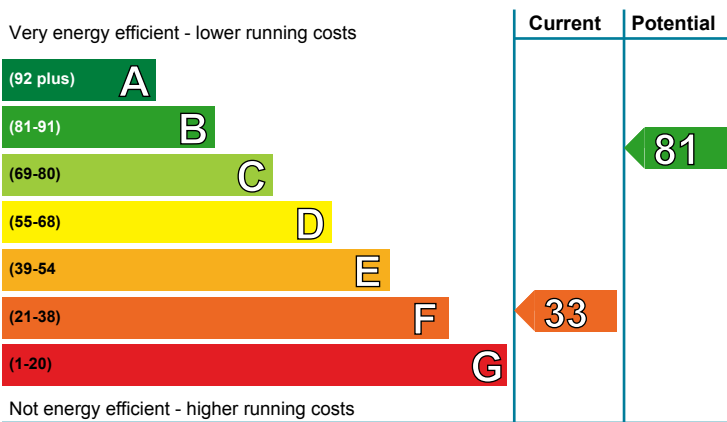
Energy Efficiency Rating

This graph shows the current efficiency of your home, taking into account both energy efficiency and fuel costs. The higher this rating, the lower your fuel bills are likely to be.

Your current rating is **band F (33)**. The average rating for EPCs in Scotland is **band D (61)**.

The potential rating shows the effect of undertaking all of the improvement measures listed within your recommendations report.

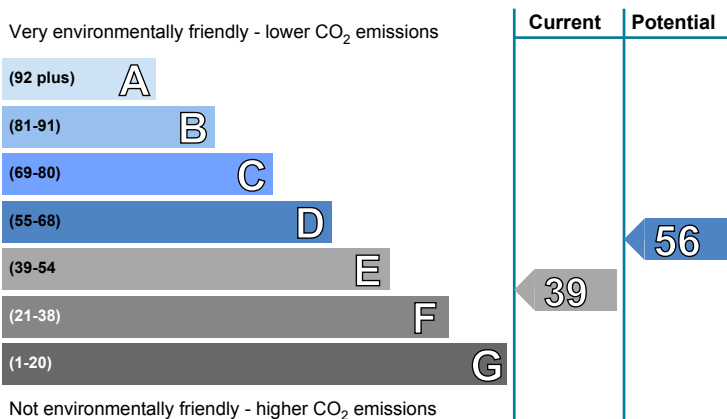
Environmental Impact (CO₂) Rating

This graph shows the effect of your home on the environment in terms of carbon dioxide (CO₂) emissions. The higher the rating, the less impact it has on the environment.
