Home Report

Scottish Single Survey

Property address	7 Beacon Drive Fraserburgh AB43 9SF
Customer	John Watt, Bruce Watt and James Watt
Customer address	7 Beacon Drive Fraserburgh AB43 9SF
Prepared by	Shepherd Chartered Surveyors
Date of inspection	12/02/2024

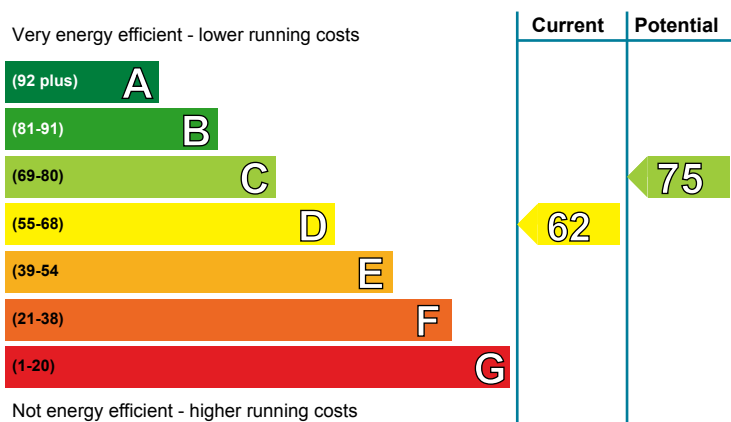
Energy Efficiency Rating

This graph shows the current efficiency of your home, taking into account both energy efficiency and fuel costs. The higher this rating, the lower your fuel bills are likely to be.

Your current rating is **band D (62)**. The average rating for EPCs in Scotland is **band D (61)**.

The potential rating shows the effect of undertaking all of the improvement measures listed within your recommendations report.

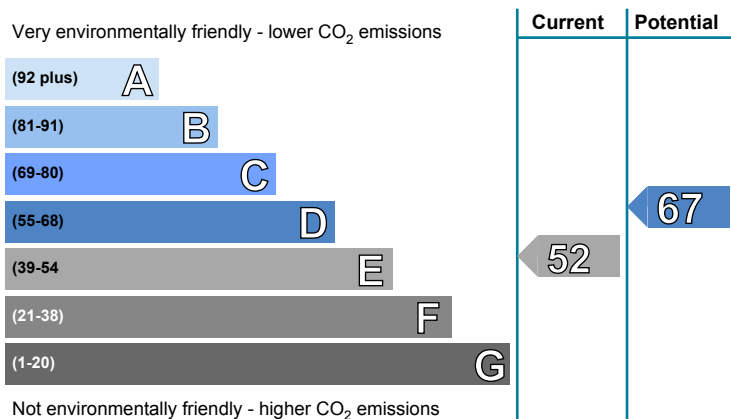
Environmental Impact (CO₂) Rating

This graph shows the effect of your home on the environment in terms of carbon dioxide (CO₂) emissions. The higher the rating, the less impact it has on the environment.
