HOME
report

SINGLE SURVEY
ENERGY REPORT
PROPERTY QUESTIONNAIRE
VALUATION REPORT

Property address	Seafield, 23A School Street, Fraserburgh, AB43 9HT
-------------------------	---

Date of inspection	5th October 2022
---------------------------	------------------

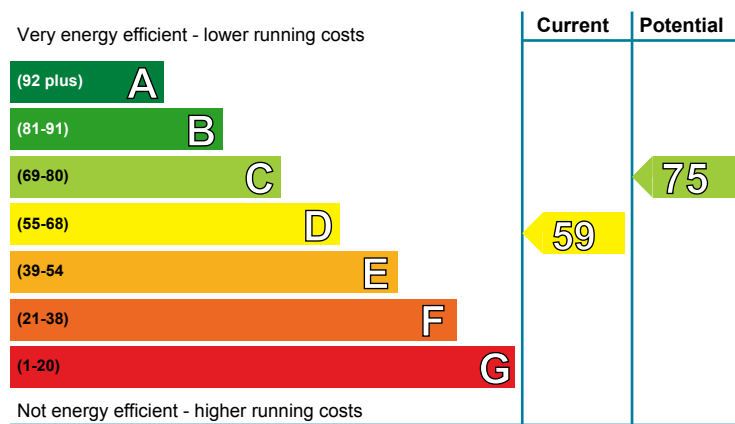
Energy Efficiency Rating

This graph shows the current efficiency of your home, taking into account both energy efficiency and fuel costs. The higher this rating, the lower your fuel bills are likely to be.

Your current rating is **band D (59)**. The average rating for EPCs in Scotland is **band D (61)**.

The potential rating shows the effect of undertaking all of the improvement measures listed within your recommendations report.

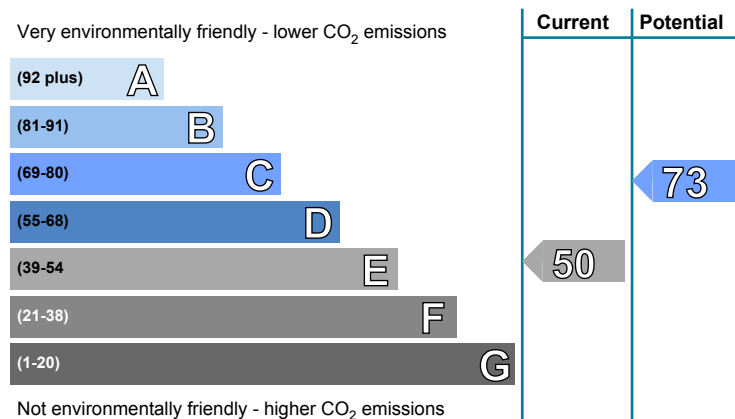
Environmental Impact (CO₂) Rating

This graph shows the effect of your home on the environment in terms of carbon dioxide (CO₂) emissions. The higher the rating, the less impact it has on the environment.
