HOME
report

SINGLE SURVEY
ENERGY REPORT
PROPERTY QUESTIONNAIRE
VALUATION REPORT

Property address	22 Albert Street, Fraserburgh, AB43 9JJ
-------------------------	---

Date of inspection	30th November 2021
---------------------------	--------------------

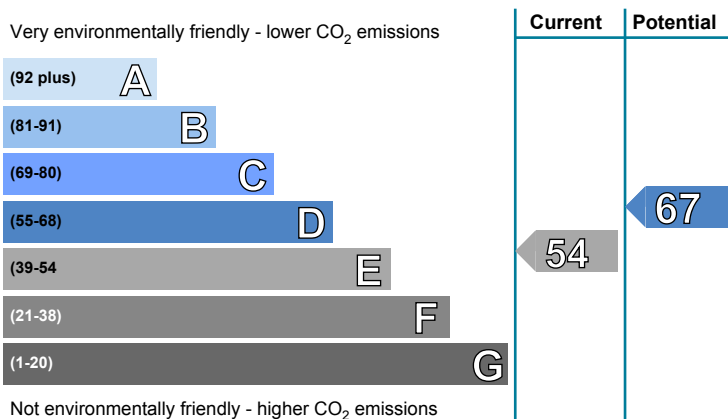
Environmental Impact (CO₂) Rating

This graph shows the effect of your home on the environment in terms of carbon dioxide (CO₂) emissions. The higher the rating, the less impact it has on the environment.
