HOME
report

SINGLE SURVEY
ENERGY REPORT
PROPERTY QUESTIONNAIRE
VALUATION REPORT

Single Survey

Property Address	249 West Road Fraserburgh AB43 9NP
Customer	Mr I Hutcheson & Mrs M Cowie, Mrs F West
Date of Inspection	05/04/2024
Prepared by	Keith Alexander Harvey Donaldson & Gibson Chartered Surveyors

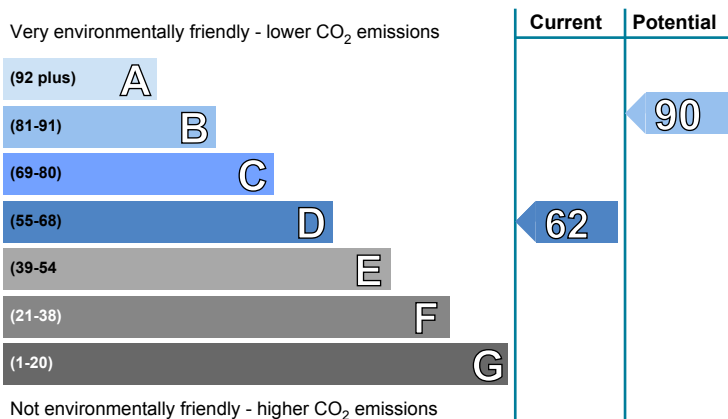
Environmental Impact (CO₂) Rating

This graph shows the effect of your home on the environment in terms of carbon dioxide (CO₂) emissions. The higher the rating, the less impact it has on the environment.
