Home Report

Scottish Single Survey

Property address	4 Shore Street Sandhaven Fraserburgh AB43 7ER
Customer	Executors of the late Raymond Faithfull
Customer address	4 Shore Street Sandhaven Fraserburgh AB43 7ER
Prepared by	Shepherd Chartered Surveyors
Date of inspection	17/04/2026

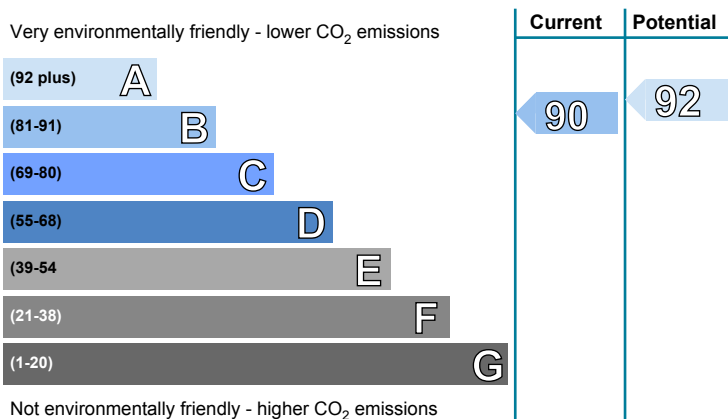
Environmental Impact (CO₂) Rating

This graph shows the effect of your home on the environment in terms of carbon dioxide (CO₂) emissions. The higher the rating, the less impact it has on the environment.
