HOME
report

SINGLE SURVEY
ENERGY REPORT
PROPERTY QUESTIONNAIRE
VALUATION REPORT

Single Survey

Property address	87 St Andrews Drive, Fraserburgh, AB43 9AW
-------------------------	--

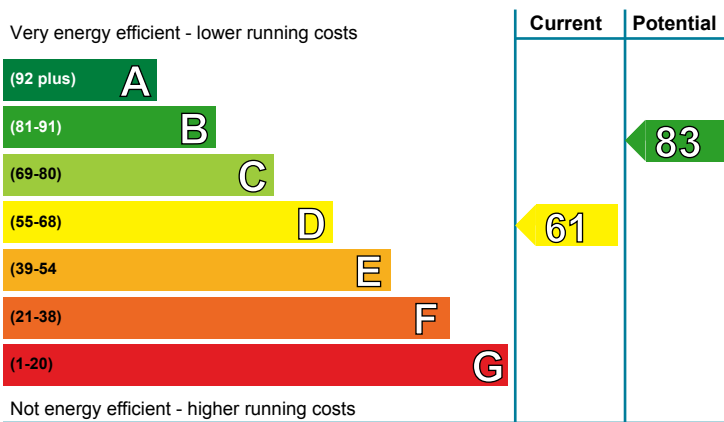
Energy Efficiency Rating

This graph shows the current efficiency of your home, taking into account both energy efficiency and fuel costs. The higher this rating, the lower your fuel bills are likely to be.

Your current rating is **band D (61)**. The average rating for EPCs in Scotland is **band D (61)**.

The potential rating shows the effect of undertaking all of the improvement measures listed within your recommendations report.

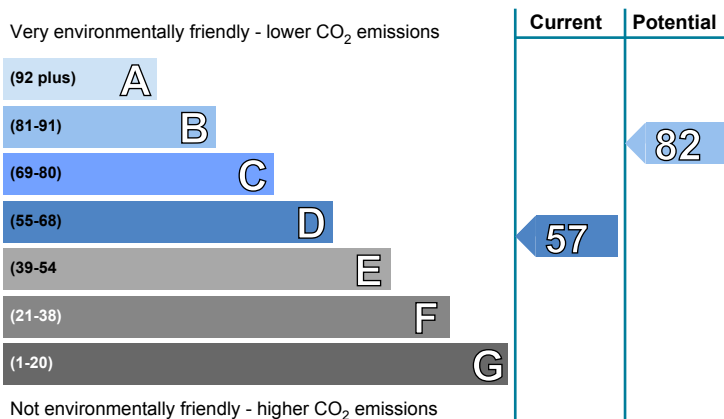
Environmental Impact (CO₂) Rating

This graph shows the effect of your home on the environment in terms of carbon dioxide (CO₂) emissions. The higher the rating, the less impact it has on the environment.
